Notes on diesel pump timing on a V70 2.5 Tdi D5252T engine.

I have just changed the belts on my 1998 V70 diesel and thought that I would put some notes together for future reference and for the possible assistance of others.

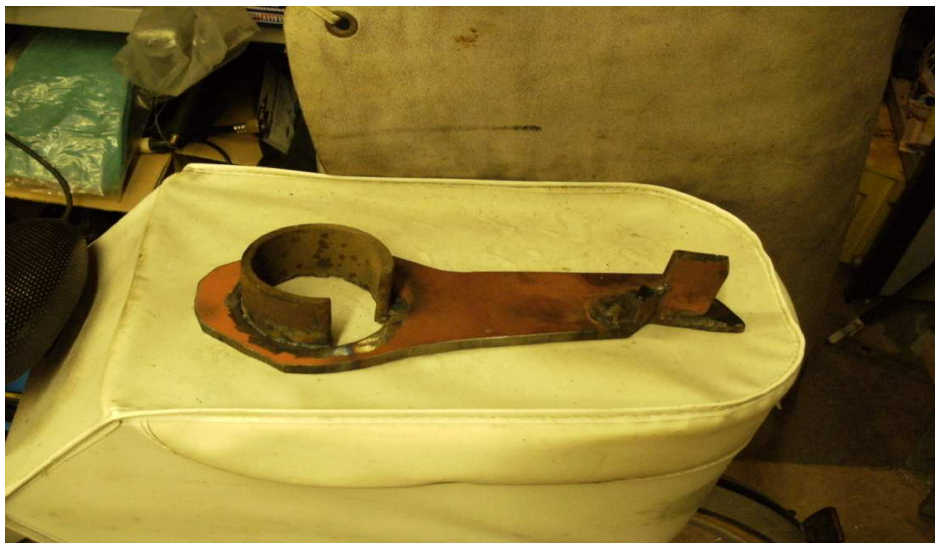
Illustration 1: Crankshaft locking tool

This was constructed from a piece of 75mm thick walled tube (cut and beaten to fit in the vibration damper centre) welded into a piece of 10mm plate cut to fit such that the protruding platform rested upon the engine mount bracket when loosening and the other side rested on the subframe rail when tightening.

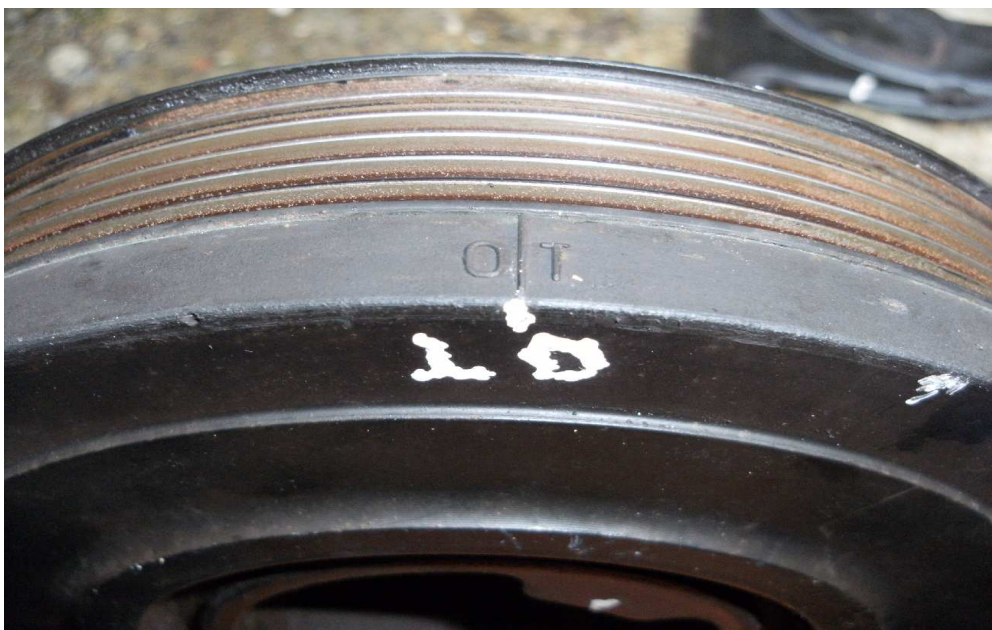
Illustration 2: TDC Timing mark on vibration damper

Illustration 2 shows the timing mark on the vibration damper. I have made this more obvious with the use of Tipp-Ex Shake'n Squeeze correction fluid.

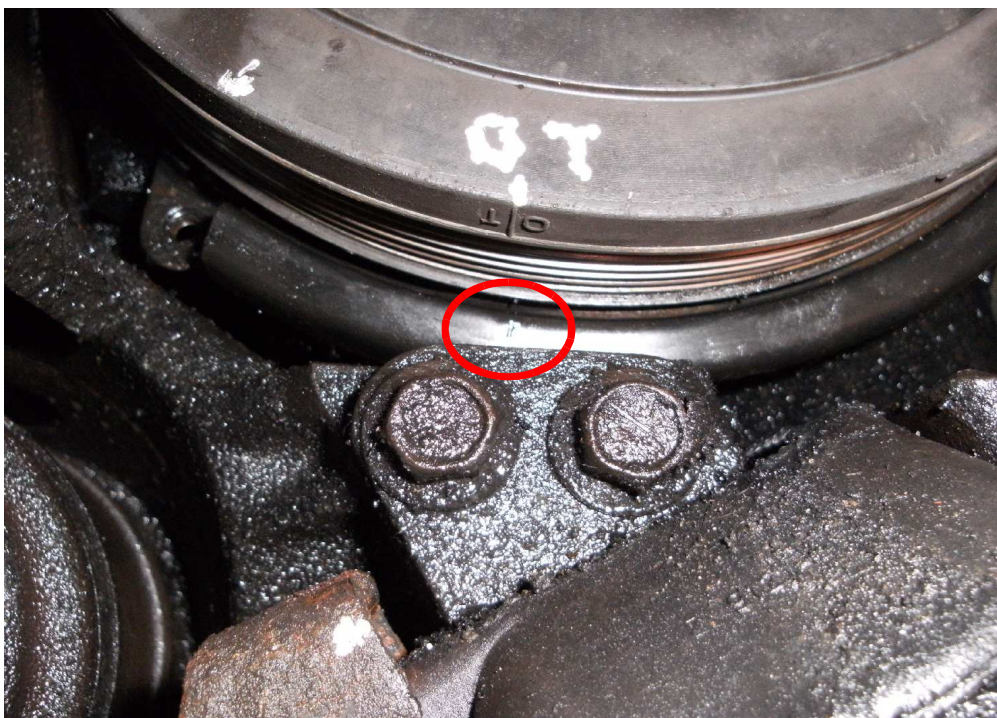
Illustration 3: TDC timing mark on Cambelt lower cover

Illustration 3 shows the timing mark on the cambelt lower cover. This also has been highlighted although it's not a good photo. This mark is at about 7.30, bottom left quadrant visible through the wheel arch liner when folded back.

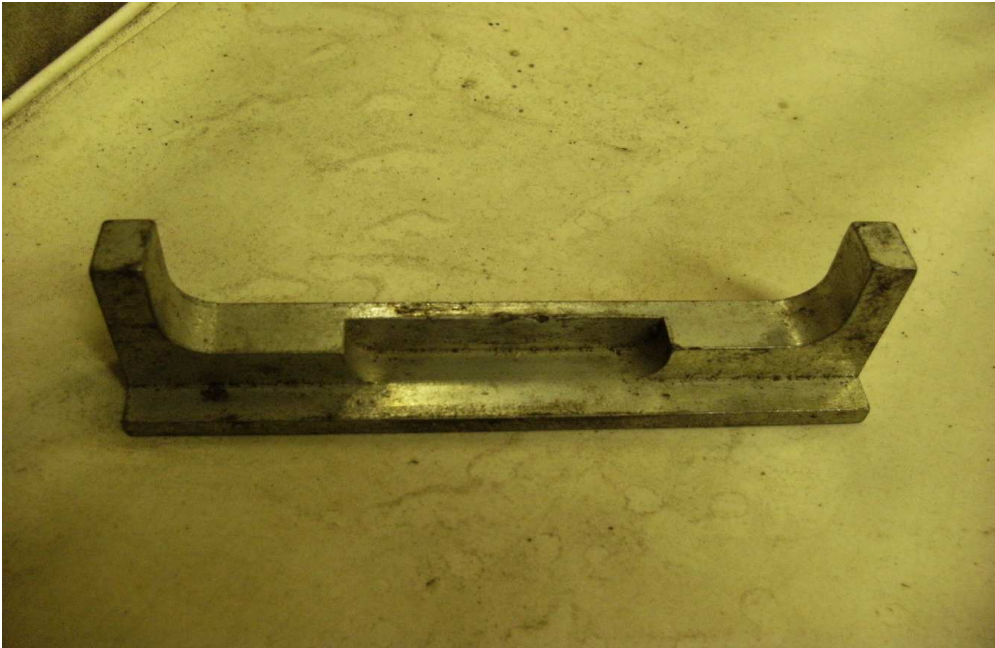
Illustration 4: Camshaft locking bar

Illustration 4 shows the locking bar for the camshaft. This can be fitted into an offset slot in the diesel pump end of the camshaft when no. 1 cylinder is at TDC (both valves closed.) after the pump drive pulley has been removed. This one is from a Sykes Pickavent set bought for an Audi 80 but seems to fit most VAG engines.

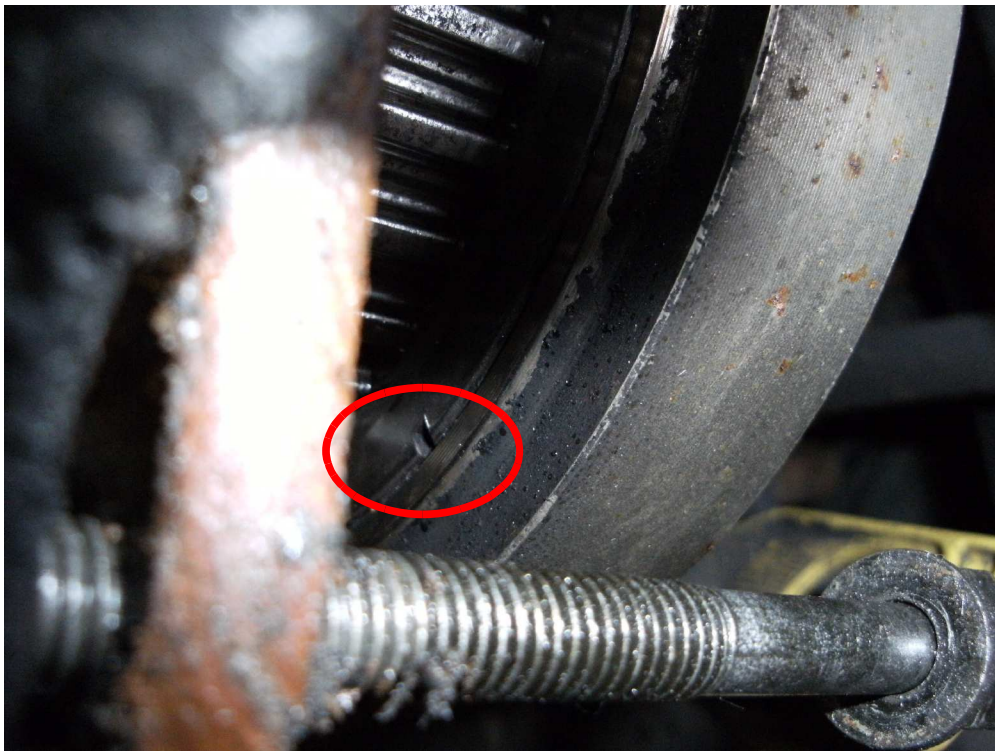
Illustration 5: Diesel pump flywheel timing mark

Illustration 5 shows the initial set timing mark on the diesel pump flywheel inner face.

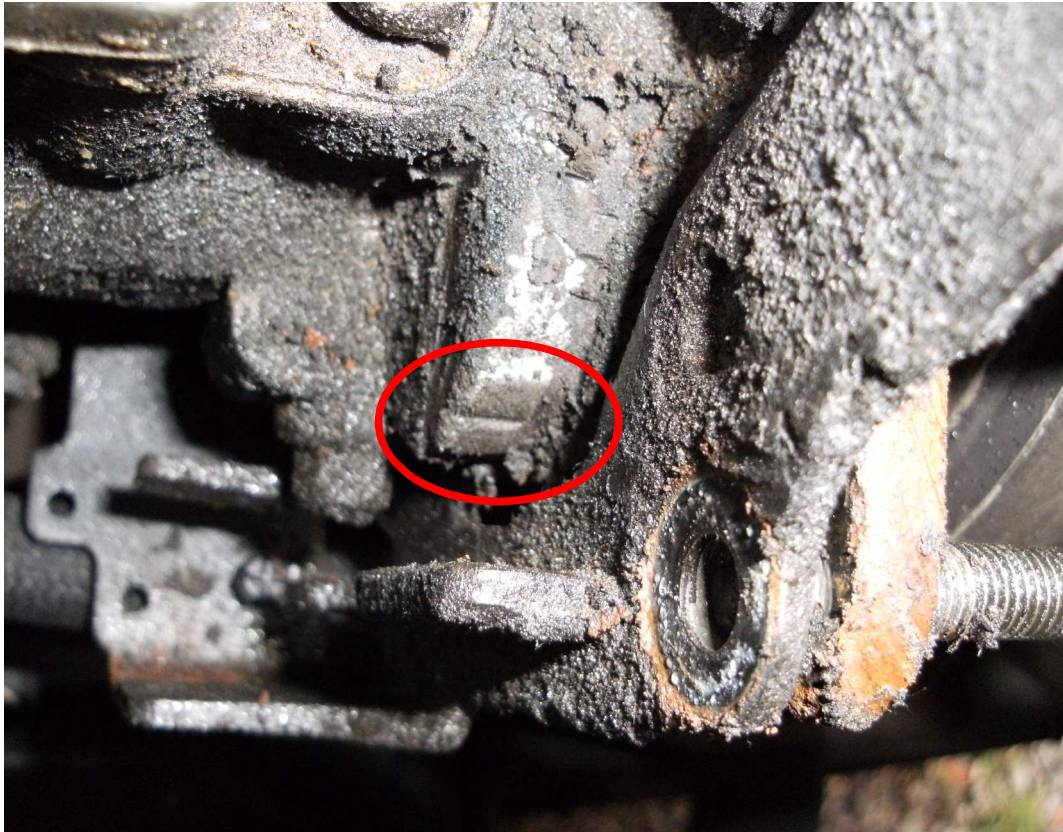
Illustration 6: Pump body timing mark

Illustration 6 shows the reference mark on the pump body against which the mark on the pump flywheel is aligned.

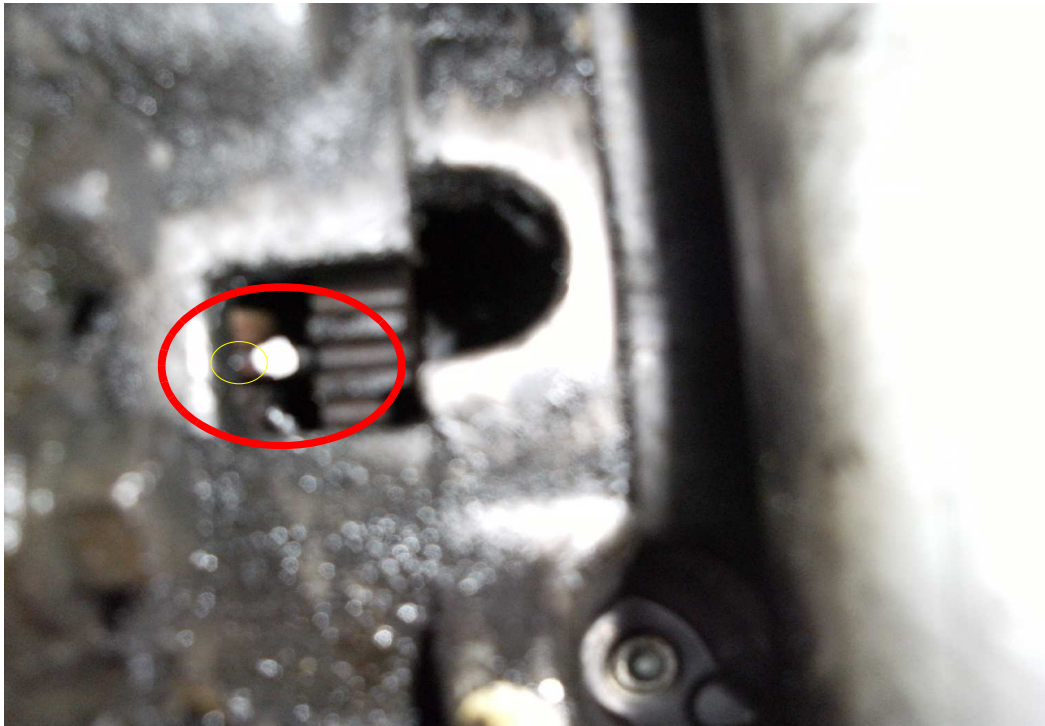
Illustration 7: Timing peg on flywheel (fuzzy)

Illustration 7 shows the timing peg (highlighted white with Tipp -Ex and out of focus) through the inspection hole which is exactly at the bottom of the flywheel housing. Sorry for the poor quality photo.

This lines up with a small pip on the inner face of the flywheel housing, ringed faintly in yellow.
